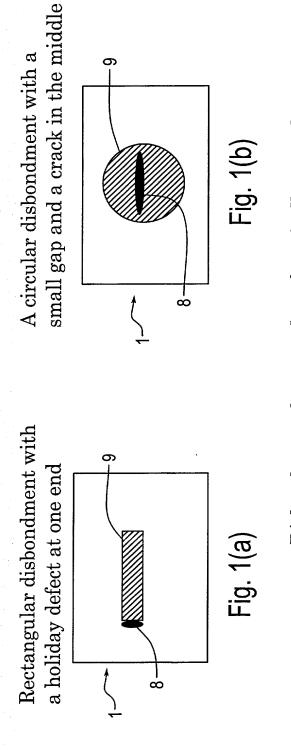
Disbondment along overlap of a spirally wound tape coating and a holiday at one section
